Damage in Rio Dell from Ferndale Earthquakes 20 December 2022 and 1 January 2023

Bruce Maison, S.E., M.EERI

July 2023

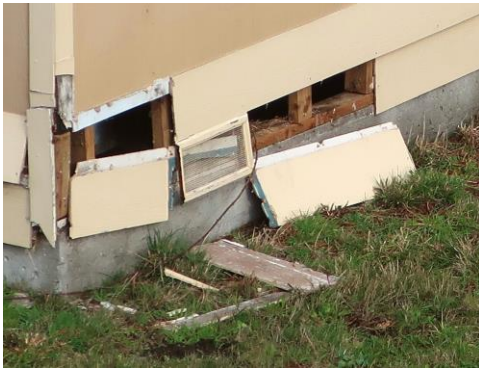
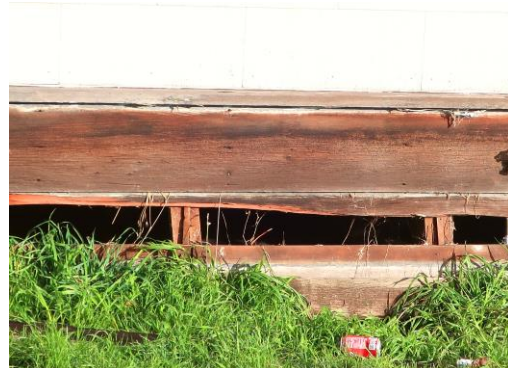
Figure 5.2. Examples of raised-floor foundation systems. (a) Newer home with sheathing consisting of siding that simply fell off. (b) Older home with sheathing consisting of horizontal boards that split.

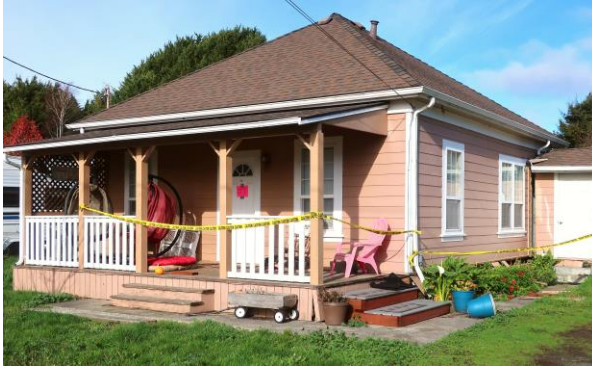
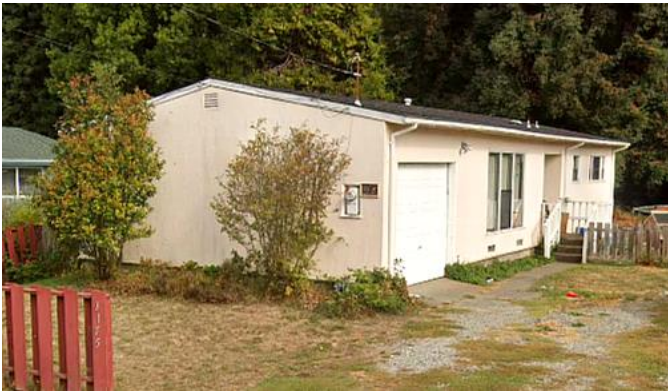
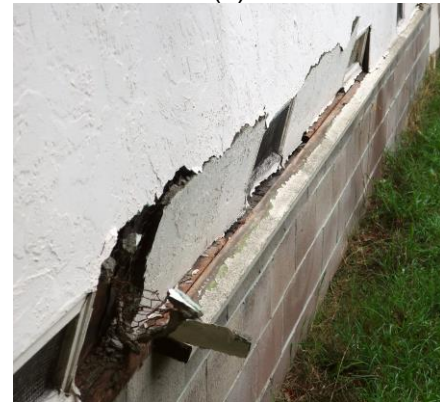
Figure 5.3. Examples of homes that shifted at floor level of raised-floor foundations. (a) Home that was offset west (to the left). (b) Close-up showing home shifted off foundation. (c) Before earthquake view of home having perimeter concrete masonry unit (CMU) wall foundation (undated Bing maps street view image). Home built circa 1948. (d) After earthquake view showing offset at foundation level.

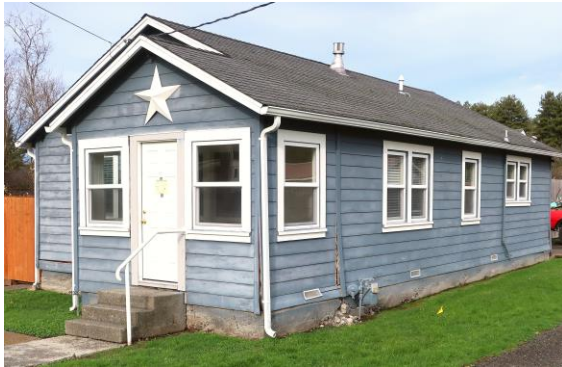
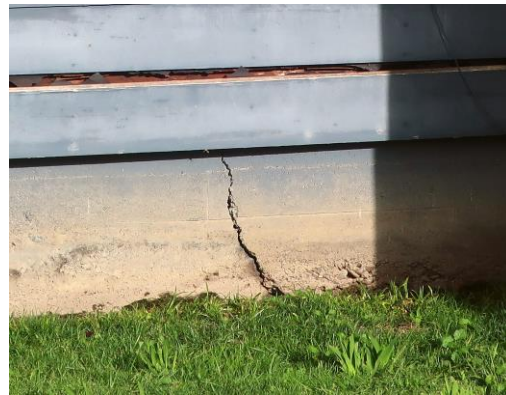
Figure 5.5. Example of home having offset at raised floor and cracking of perimeter concrete footing. (a) Exterior view of home. (b) Close-up view of fracture at cold joint apparently having inadequate bonding between layers of concrete. Home offset indicated by gap behind vertical molding. (c) Vertical crack in footing. Home offset indicated by splitting of molding at corner of home. (d) Vertical crack in footing.

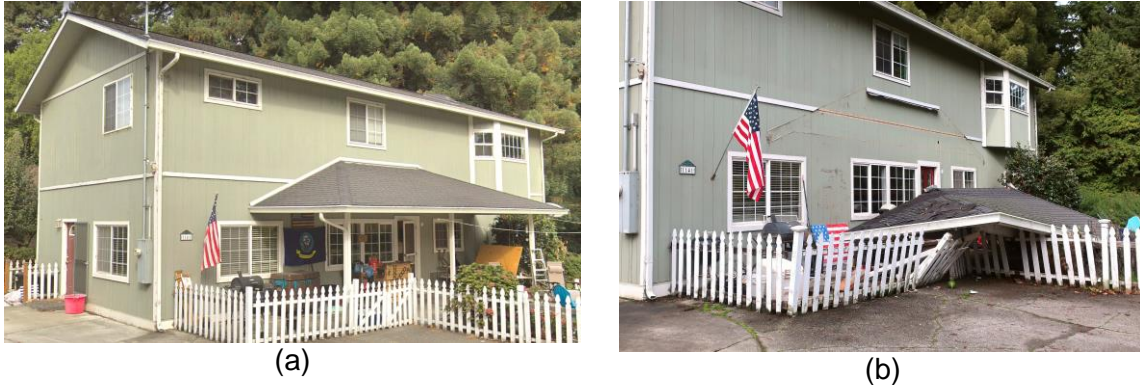
Figure 5.6. Example of home that suffered porch roof collapse (home built circa 2000). (a) Before earthquake (undated Google maps street view image). (b) View after earthquake with porch roof on ground and crushing fence.

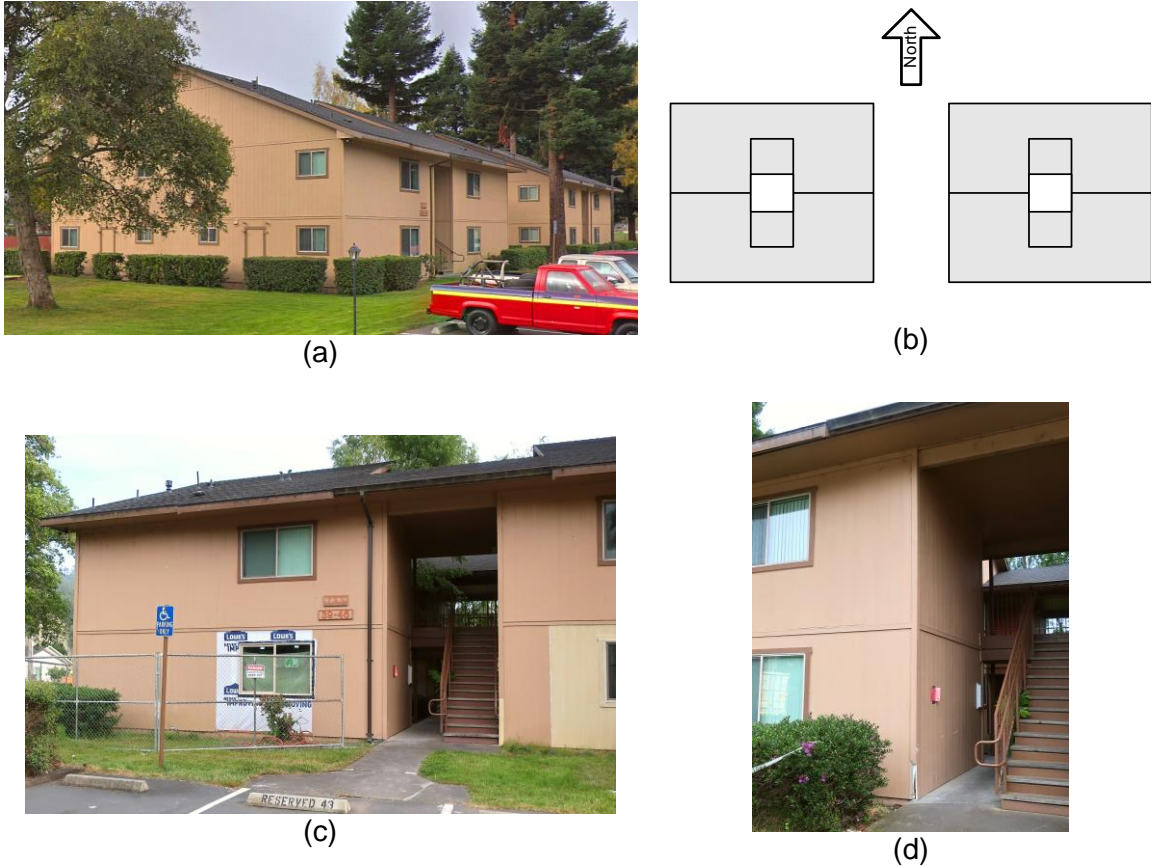
Figures 5.7 and 5.8 show the damage observed in newer apartment buildings. Such apartment buildings are rare in Rio Dell (Figure 4.1a). The buildings have rigid fiber-cement siding that suffered much cracking from building lateral drifts during the earthquakes. Such siding is brittle and readily cracks under excessive deformations.

Figure 5.7. Damaged apartment buildings (built in 1992). Photos taken in May 2023 during repairs. (a) View prior to earthquakes (undated Google maps street view image). There are two identical buildings each having eight apartment units (second building is in background to the right). Both buildings suffered damage. (b) Building plan views. (c) Building undergoing replacement of window and siding. (d) Damage to fiber-cement siding at corner of building at base (photo center).

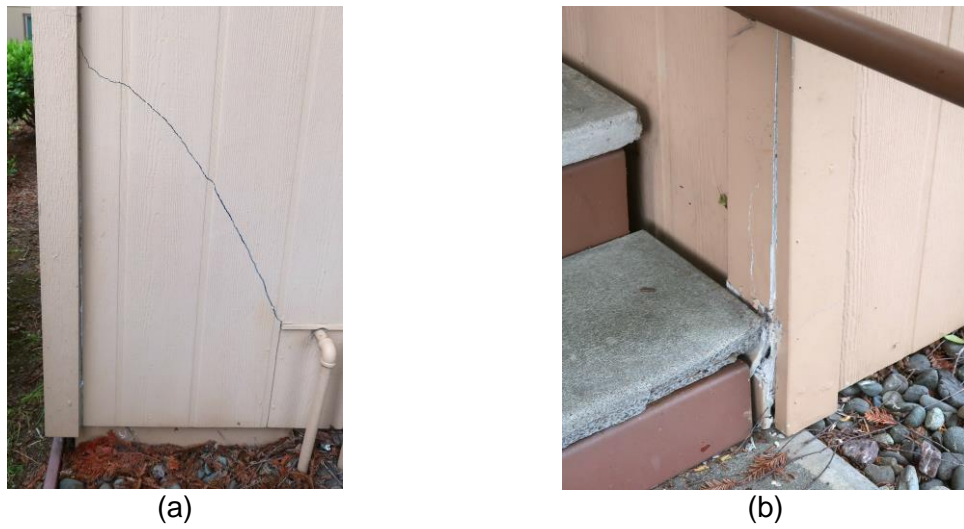
Figure 5.8. Examples of damage to rigid fiber-cement siding. Buildings had extensive siding damage. (a) Diagonal crack in siding. (b) Broken vertical molding.

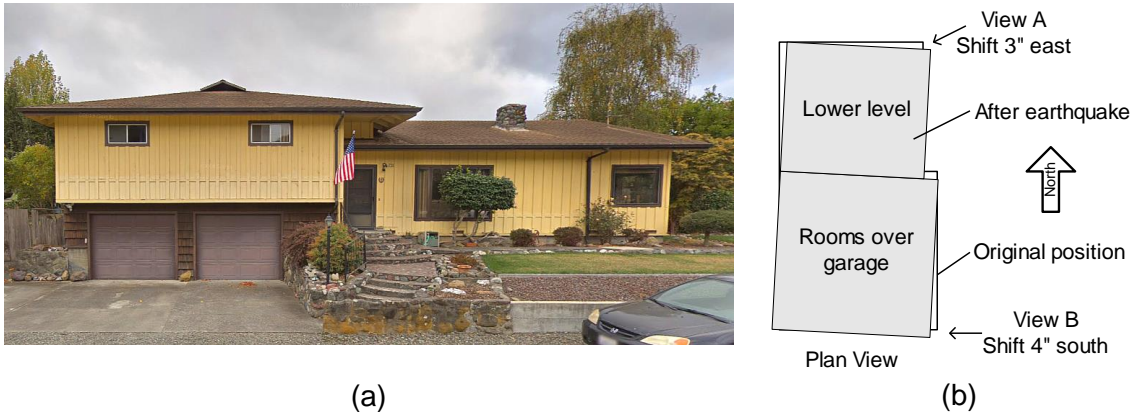
Figure 5.9. Split-level home that suffered damage. (a) Street view of home before earthquake (undated Google maps street view image). Home built in 1962. The upper level rooms over garage (on the left) are situated on stepped concrete footing stem walls with cripple walls extending from top of walls to floor elevation above. Cripple walls are shorter toward the back of garage. The lower level (on the right) has floor joists sitting on wood sill plates situated on top of footing stem walls (no cripple walls). (b) Plan view depicting shifting of home caused by earthquakes.

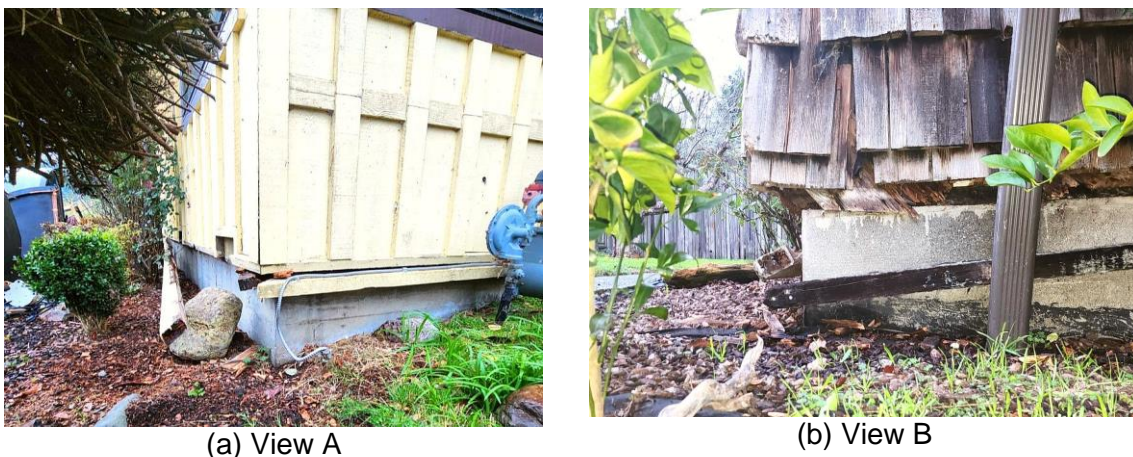
Figure 5.10. Close-up views of home showing offsets caused by earthquakes (Figure 5.9b). (a) View A (Figure 5.9b). Sill plate was split and home moved to the east at this corner (to the left). (b) View B. Sill plate was split and home moved to the south at this corner (to the left). Cripple wall above was also tilted to the south. There were some anchor bolts connecting sill plates to concrete foundation.

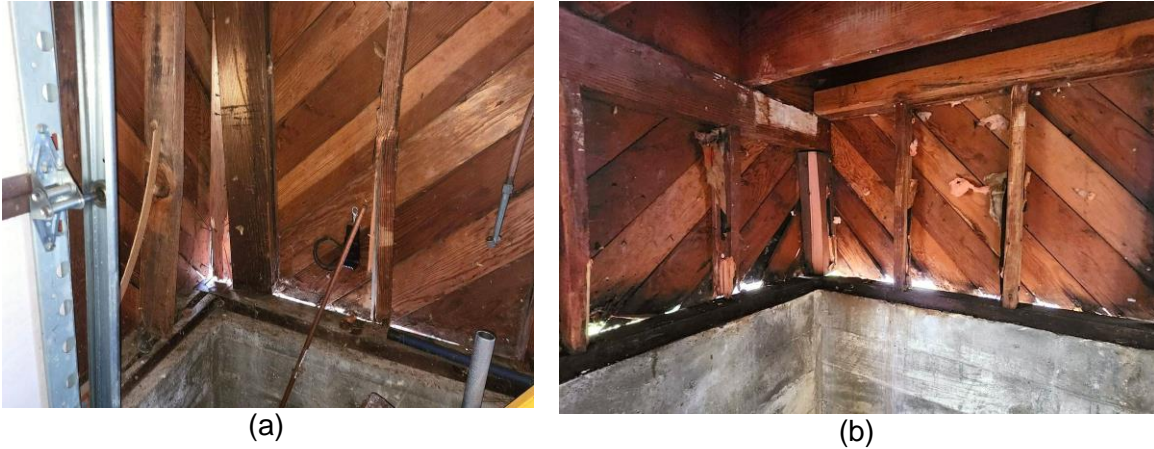
Figure 5.11. Views of cripple walls from inside garage. Cripple walls were sheathed by diagonal wood boards. (a) View toward corner next to garage door. Notice sunlight in gap where sheathing pulled away from sill plate. Some 2x4 wall studs were fractured. (b) View toward back corner. The cripple walls are shorter here than those near garage door. Notice the separation of sheathing from sill plate. There was evidence of wood deterioration even though redwood has good decay resistance. Deterioration might have been caused by wood shake siding trapping moisture (Figure 5.10b).

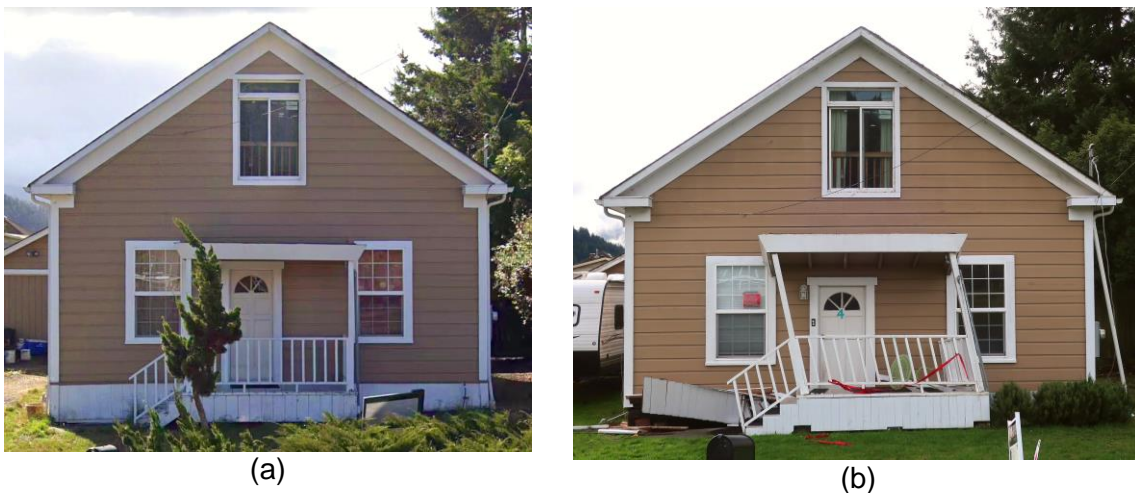
Figure 5.12 shows an older home built circa 1910 that suffered damage. Neighbors stated that home was relocated to current site many years ago. The raised floor foundation system consisted of precast concrete piers and short wood posts supporting the wood floor system (post-and-pier system). The home was completely thrown off its foundation. The home itself behaved like a rigid box and appeared to have no significant structural damage (Figure 5.12b). Figures 5.13, 5.14 and 5.15 show damage at the foundation level caused by the earthquakes.

Figure 5.12. Home that fell due to failure of post-and-pier foundation system (east side is on left). (a) Before earthquake (undated Google maps street view image). (b) After earthquake. Home fell in the east direction. Notice tilting of porch posts and gutter downspout (at right) indicating large displacement of home.

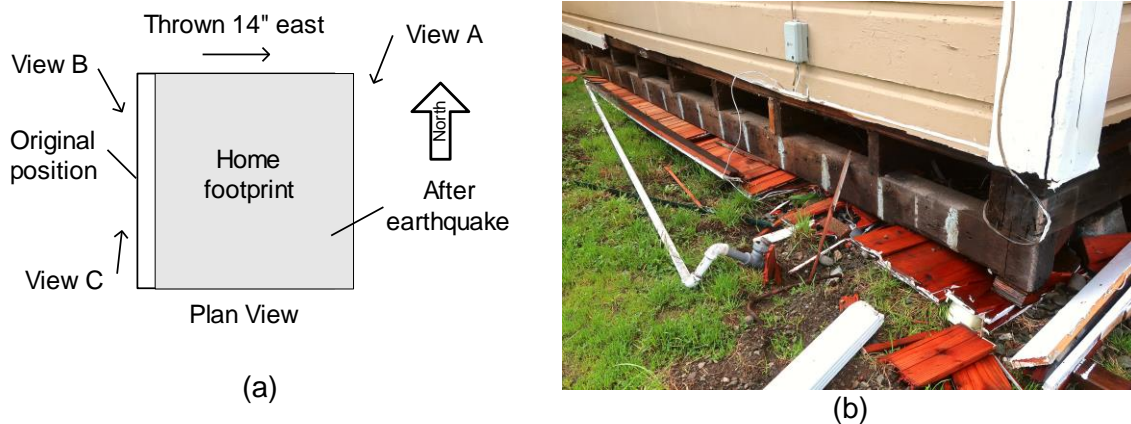
Figure 5.13. (a) Plan view indicating that home fell directly toward the east. (b) View A along east side of home. Home fell to the left and now sitting on siding that is lying flat on ground.

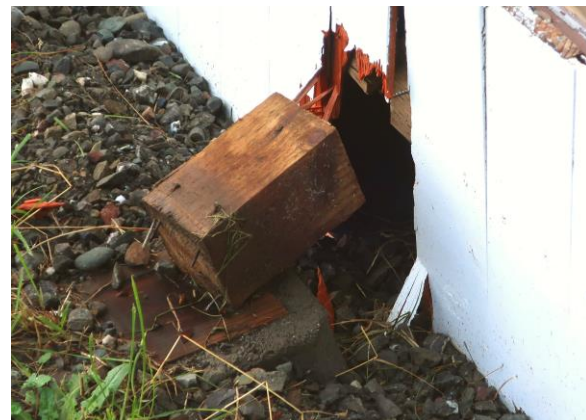
Figure 5.15. Detailed views of post-and-pier foundation system. (a) Close-up view of precast concrete pier with short 4x4 block on top. Siding sitting on top of post as home shifted to the right. (b) Close-up view of short 4x4 post lying on its side on top of pier. The assembly broke through siding as home shifted east (to the right). Post was toenailed to pier. Siding nailed to home but not connected to ground.

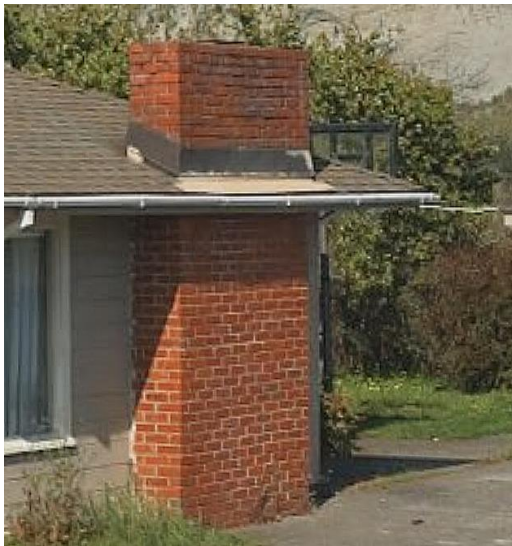
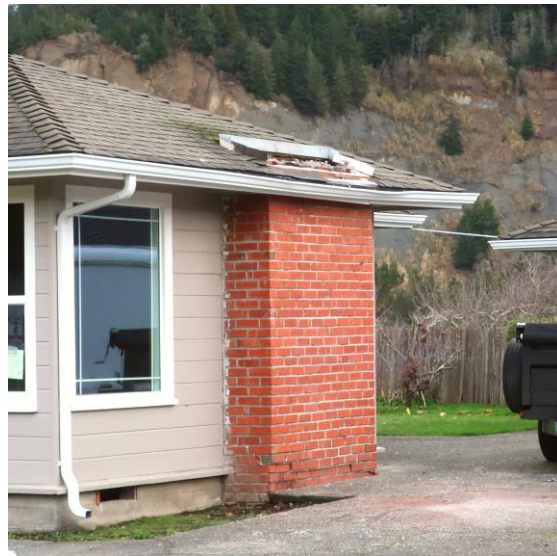
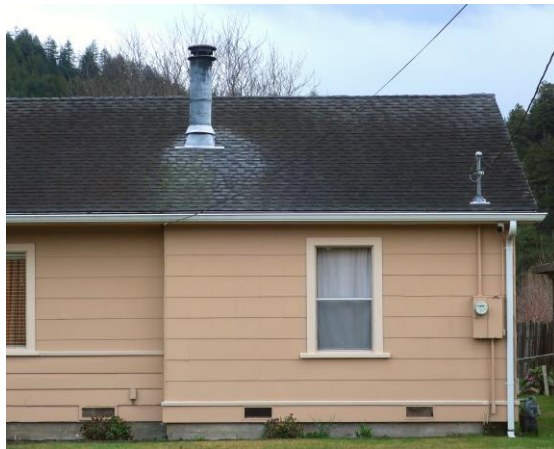
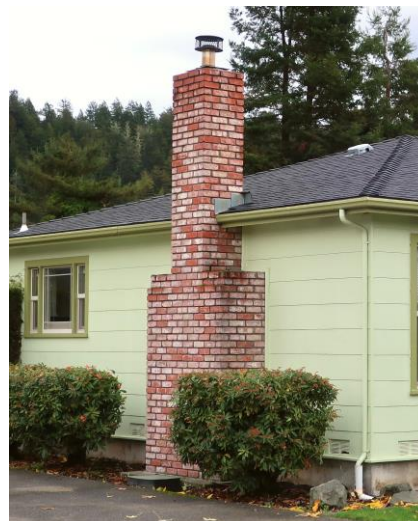
Figure 6.1. Examples of Rio Dell chimneys. (a) Before earthquake (undated Google maps street view image). Home built circa 1955. (b) After earthquake and clean-up. Chimney broke at roofline and had offset near base. Notice that home had a Green tag in window (at left). (c) Undamaged metal flue chimney on adjacent home. Likely a replacement for an original masonry chimney done some time after home originally built. (d) Undamaged masonry chimney on adjacent home. It has the appearance of newer construction installed some years ago and likely a replacement chimney.

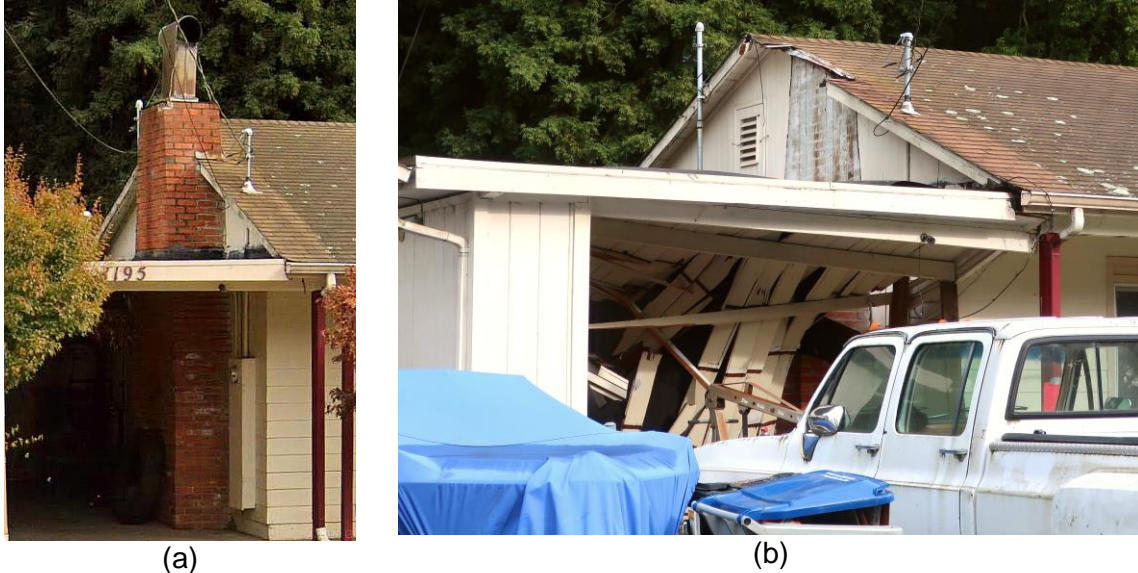
Figure 6.2. Example of masonry chimney collapse. (a) View before earthquake (undated Bing maps street view image). Home built circa 1935. (b) View after earthquake. Chimney collapsed and fell through attached carport roof. No signs of straps connecting chimney to home.

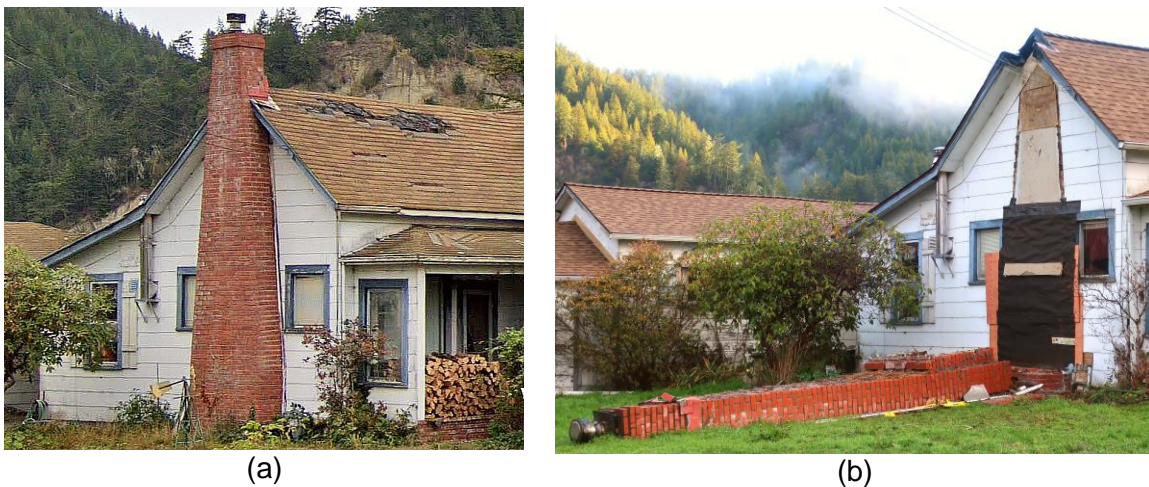
Figure 6.3. Example of masonry chimney collapse. (a) View before earthquake (undated Google maps street view image). (b) View after earthquake. Chimney fell away from home and now lying on its side in yard. It was fortunate that no adjacent structures were present that would have been impacted.

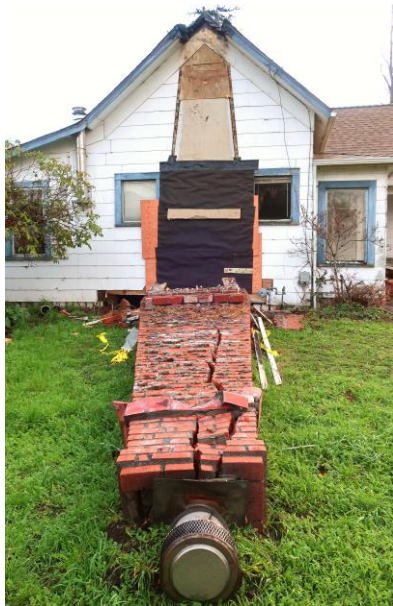
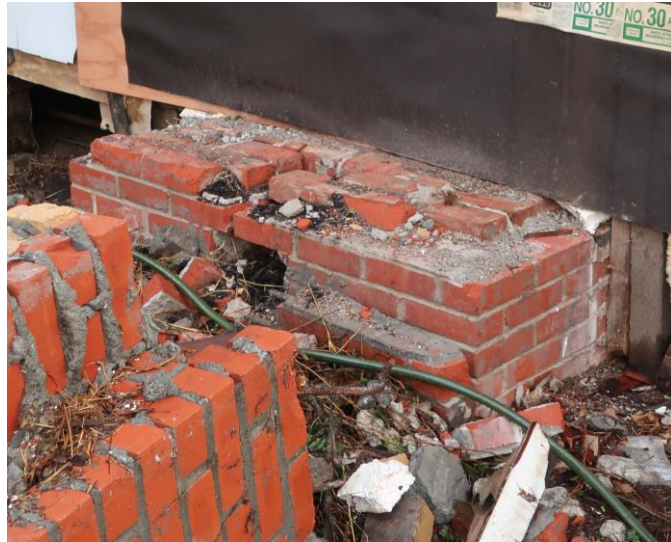
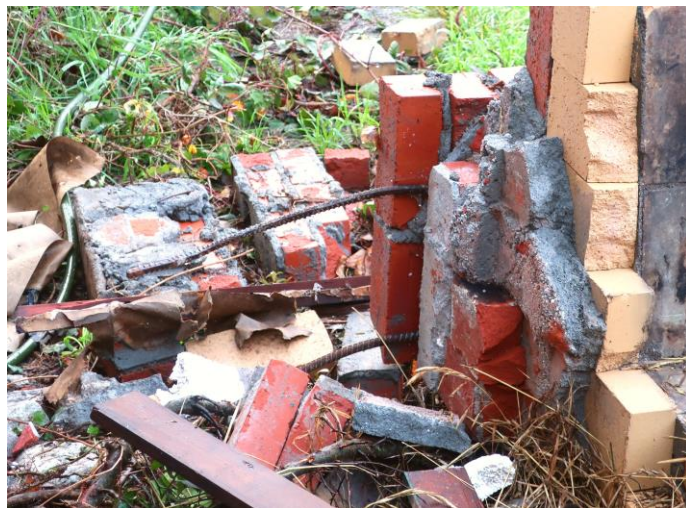
Figure 6.4. Additional photos of chimney collapse in Figure 6.3. (a) Cracking through bricks indicating good quality mortar. (b) Chimney broke off near base. (c) No signs of strapping to home. (d) Exposed rebar indicating pull-out. Four #4 bars present. Notice the good quality of mortar and use of modern deformed rebar. It is likely that the chimney was a replacement constructed some time after home was built circa 1935.

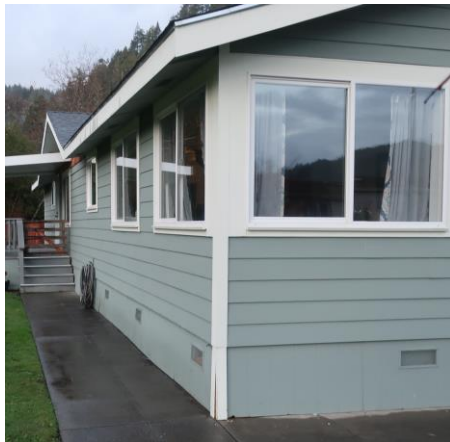
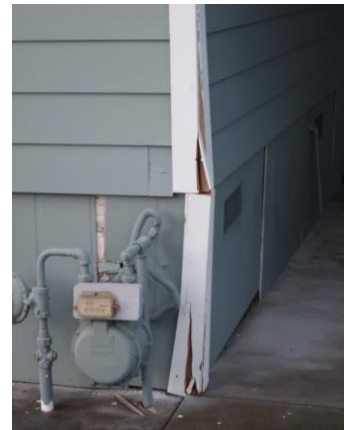
Figure 7.4. One of the few homes showing signs of distress in skirting. Offset of home is barely perceptible. (a) Splitting of vertical wood molding trim at corner of home at base. (b) Broken molding trim at opposite corner.

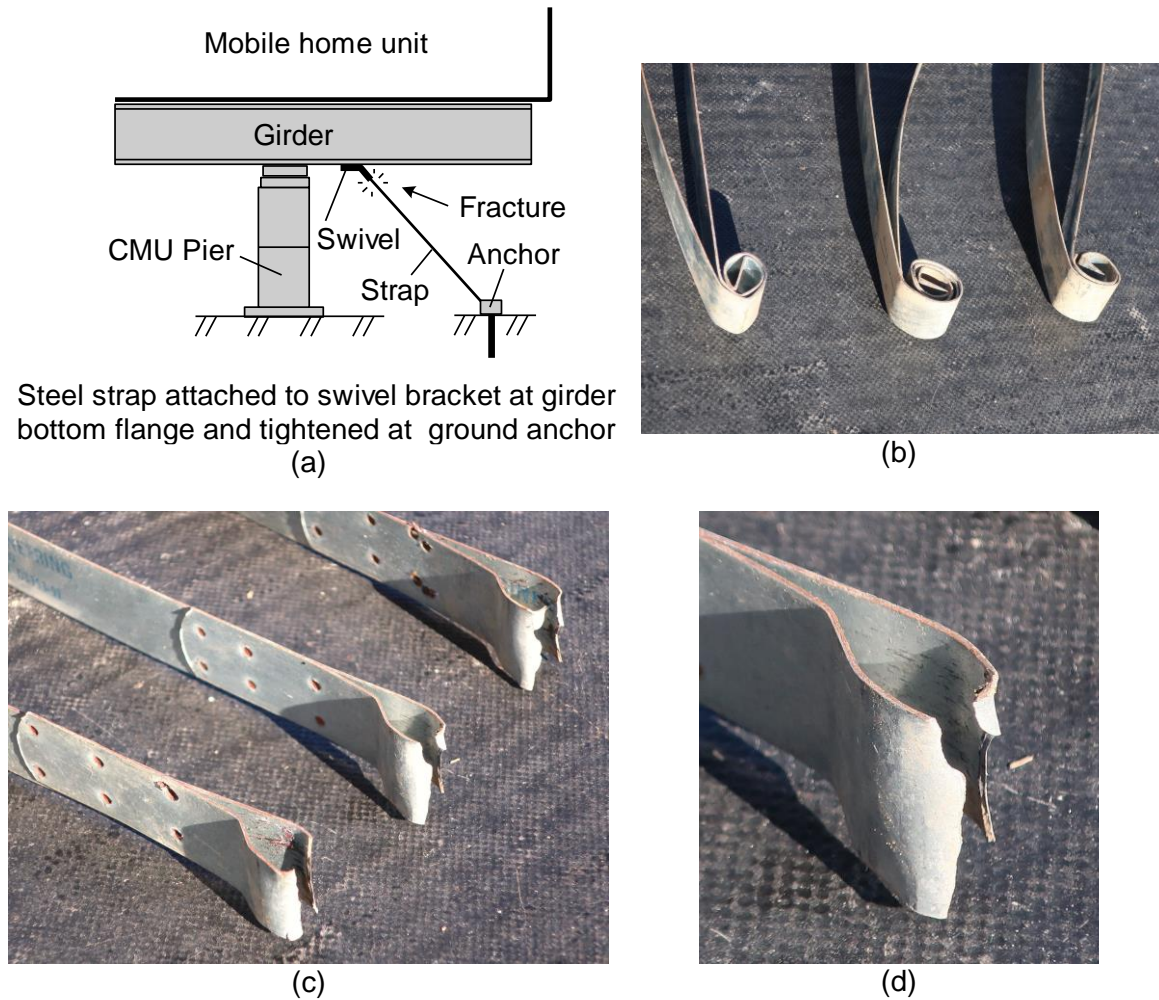
Figure 7.5. Broken tie-down straps taken from home having no signs of visible damage from the exterior. Tie-down arrangement for home longitudinal direction. Some straps were broken by earthquake. (b) Straps did not break at ground anchor spooling devices where straps were tightened. (c) Straps broke at swivel brackets where strap looped through slot in bracket. (d) Close-up view of broken strap.

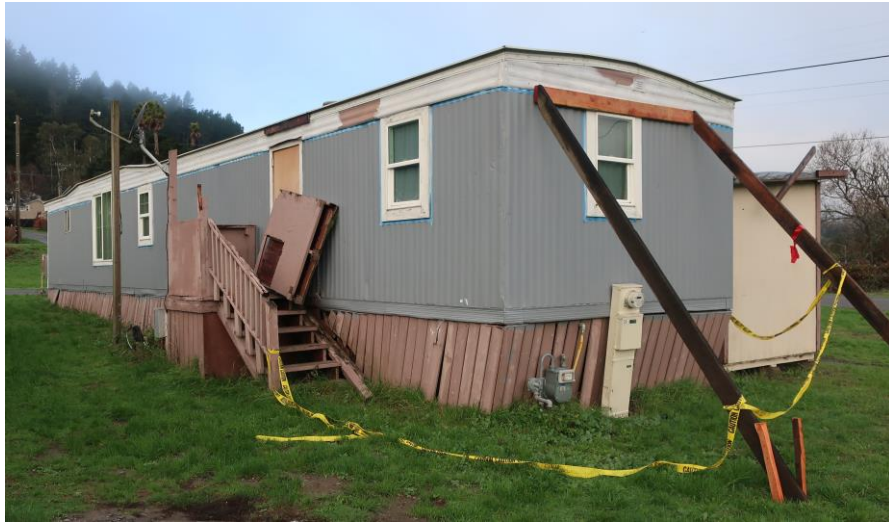
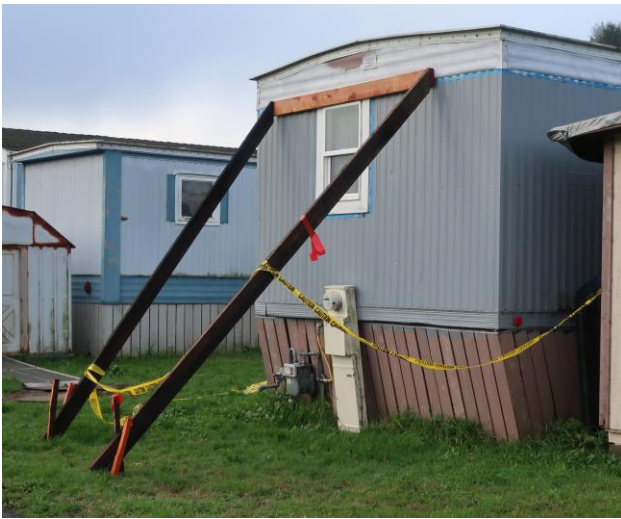
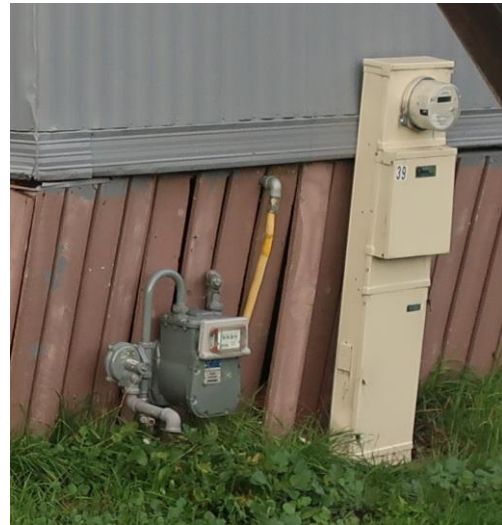
Figure 7.7. Home that was in an incipient collapse condition (shifted to the east) necessitating emergency shoring. (a) Home with shoring in place. (b) Close-up of shoring. (c) Close-up of gas and electric meters sets. Notice that home has pushed against electrical tower. This illustrates the hazard posed by a collapsing home that damage utility systems thereby possibly causing ignitions and fire following earthquake.

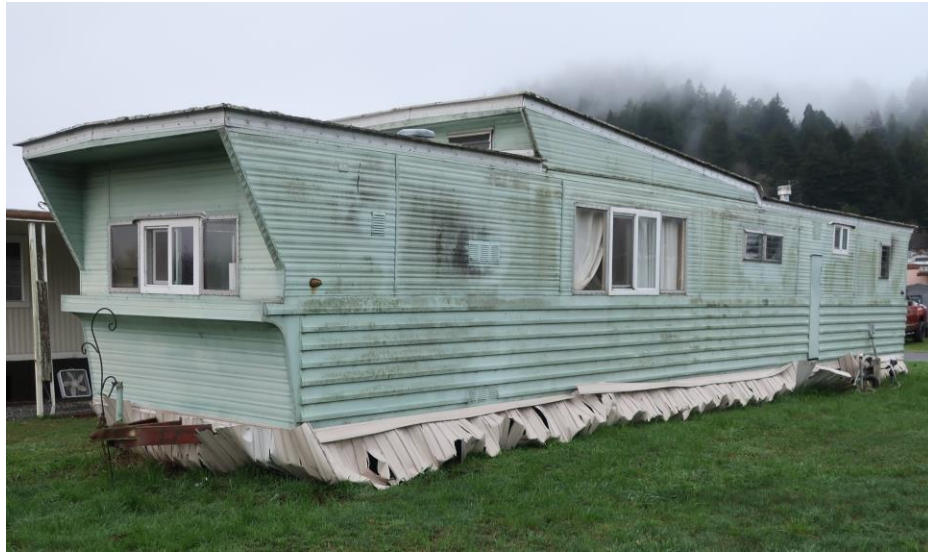
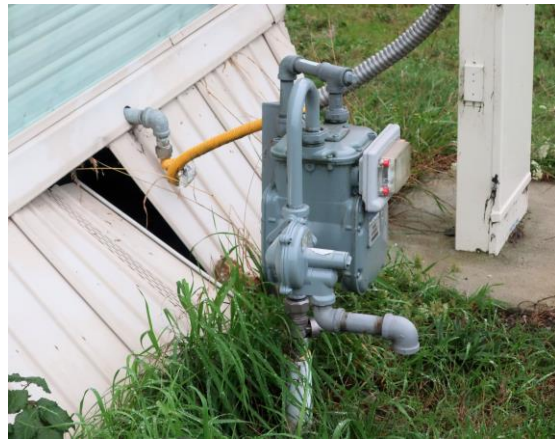
Figure 7.8. (a) Mobile home that was in an incipient collapse condition (shifted toward the east). (b) Close-up showing large displacement. Notice the distortion of skirting. (c) Gas and electrical utilities at end of home where home shifted away from meter sets thereby stretching connections.

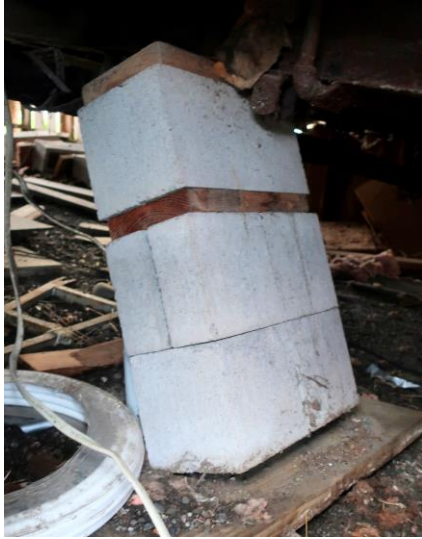
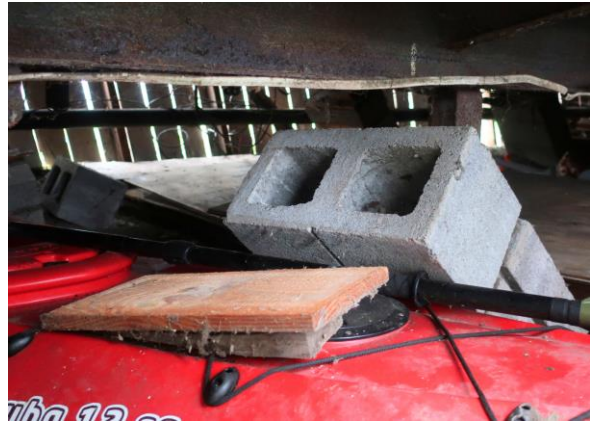
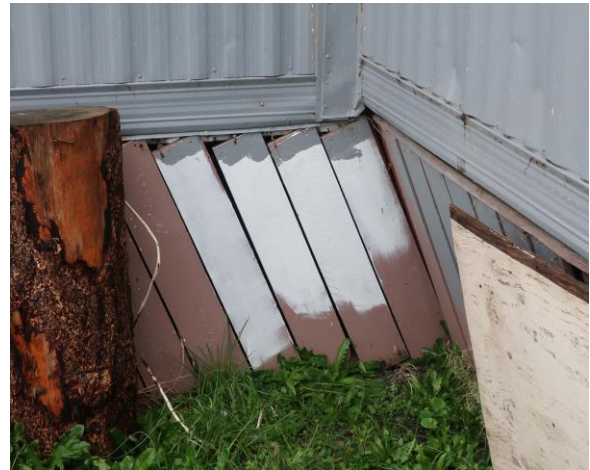
Figure 7.9. Examples of mobile home damage. (a) Tilted CMU pier resulting from home shifting. (b) CMU pier disengaged and leaning on water jet-ski stored under home. Notice wood boards resting on top of jet-ski. Before earthquake, chassis girder rested on boards situated on top of CMU. (c) CMU pier lying on side (CMU and boards at left). Precast concrete pad where CMUs were situated (at right). Sanitary pipe (at center) was located to the right of pad prior to earthquake thus indicating large movement of home. (d) Exterior view of skirting consisting of wood boards that were tilted as home shifted to the left. Many boards attached to home with one nail thus allowing boards to rotate. Such skirting if rigidly attached to home and ground possibly can help provide lateral support to home, but skirting not intended as structural elements.

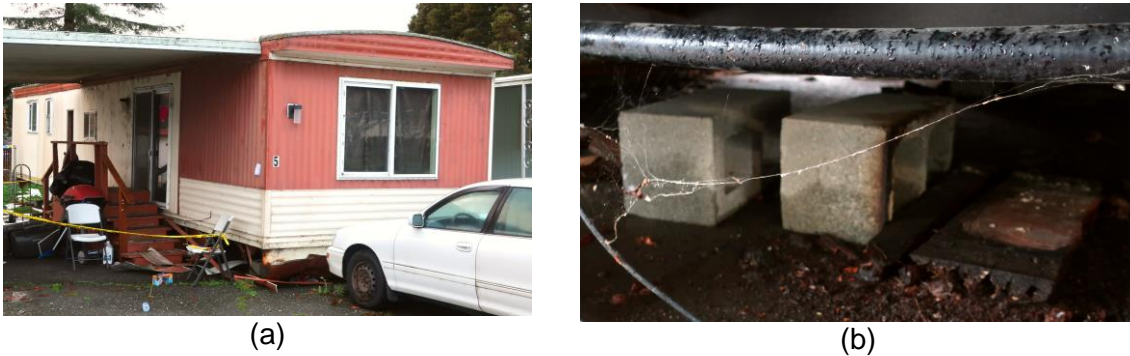
Figure 7.11. Collapsed home. (a) Home has dropped below staircase elevation. (b) View underneath home showing CMUs lying on their sides indicating that home was thrown a large distance to the east (to the left). Home did not have tie-downs.

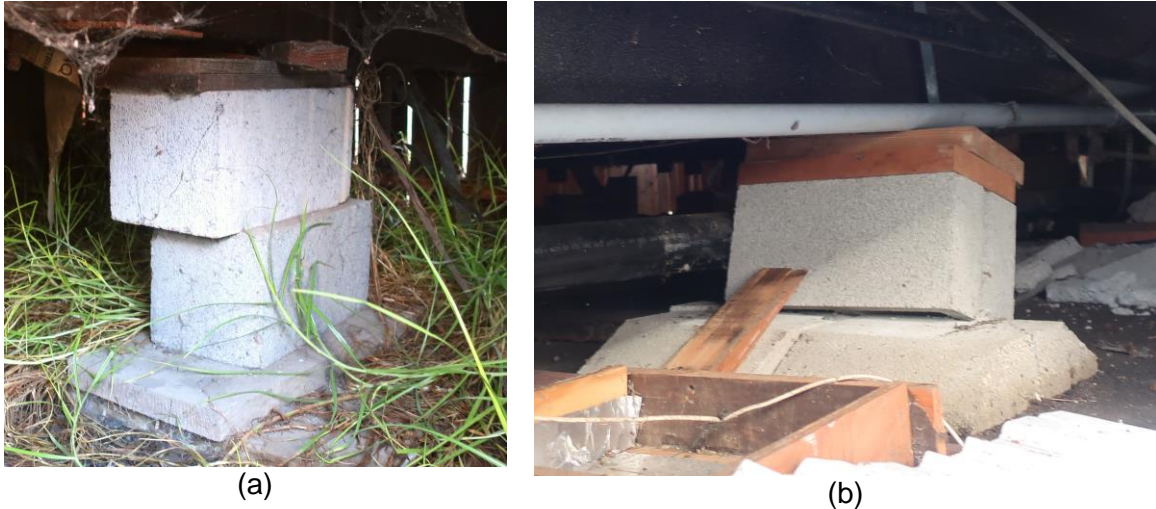
Figure 7.13. Views underneath damaged homes showing piers. (a) CMU pier that was offset (slid) between units. (b) CMU pier that slid on precast concrete pad and then tilted.

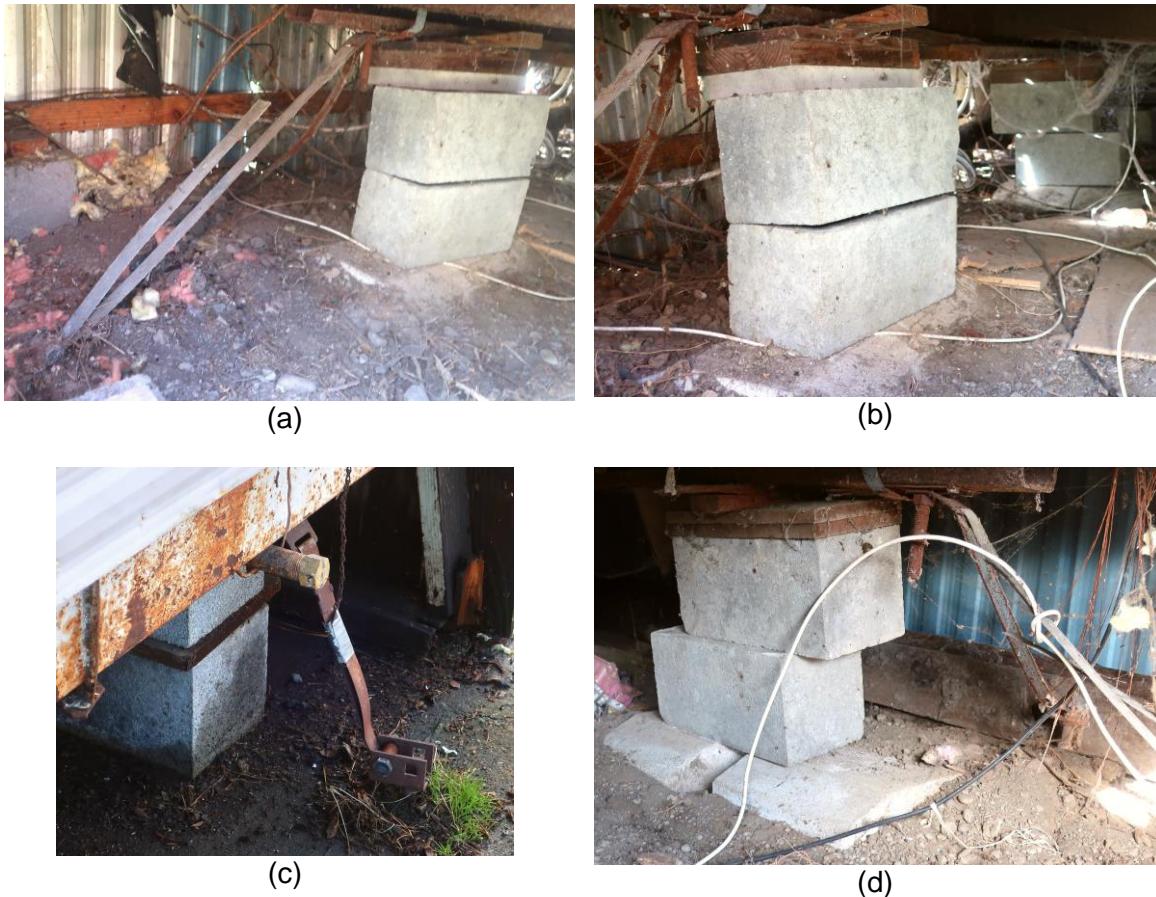
Figure 7.14. Examples of damaged homes having tie-downs. This was unexpected for the older homes in park since California required tie-downs for homes installed after 1994. (a) and (b) Tie-down (at left) did not prevent sliding and tilting of CMU piers (at right). (c) Old tie-down as evidenced by weathering. (d) Tie-down (one shown at right) and offset CMU pier (at left).

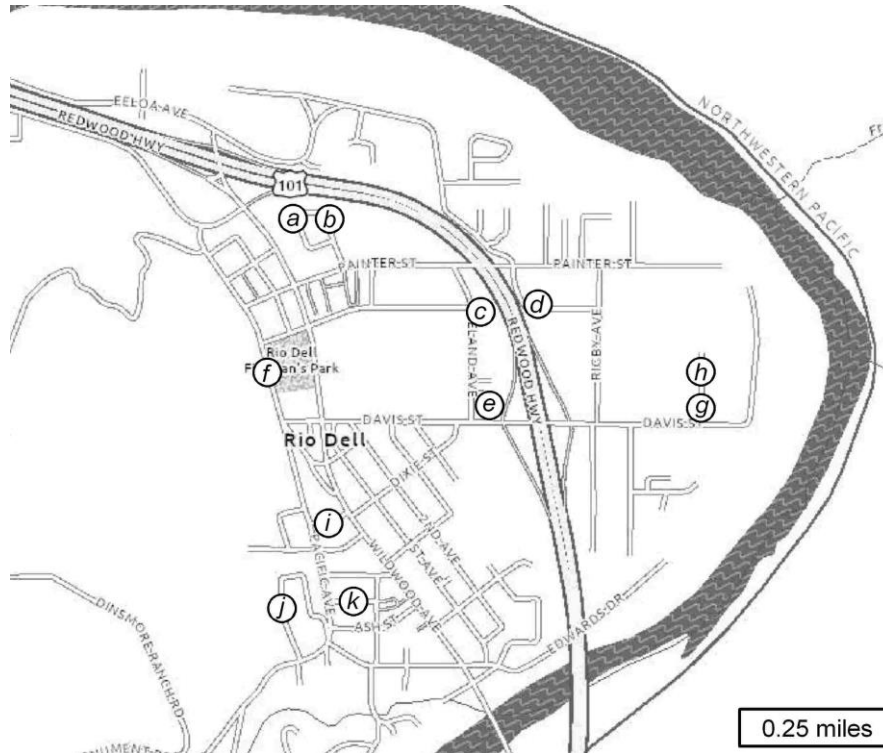
Figure 9.2. Locations of water main repairs.

Water Main Damage. Eleven water mains were damaged requiring repairs shortly after the earthquake. Figure 9.2 shows the repair locations and Table 9.1 describes pipe types. Repairs were to steel and AC pipe.
