Damage in Rio Dell from Ferndale Earthquakes 20 December 2022 and 1 January 2023

Bruce Maison, S.E., M.EERI

July 2023

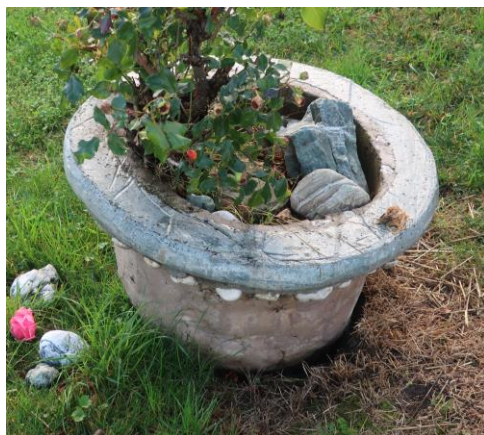
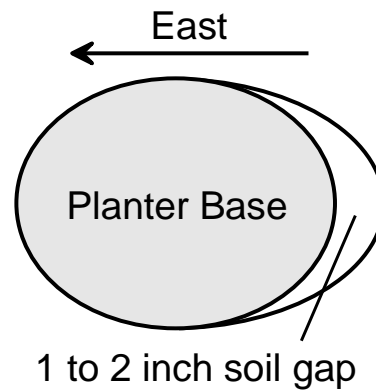
For the M6.4 earthquake, the recorded accelerations indicate that shaking was more intense in the east-west direction. Figure 3.3 shows a heavy planter pot that was shifted toward the east consistent with the recorded accelerations. Offsets toward the east were also observed in many houses and mobile homes.

Figure 3.3. Heavy concrete planter pot in front yard of home on Painter Street. Home owner specifically pointed out how planter was shifted toward the east by the earthquake. (a) Notice gap in soil at base of pot (at lower right). (b) Depiction of deformation at planter base.

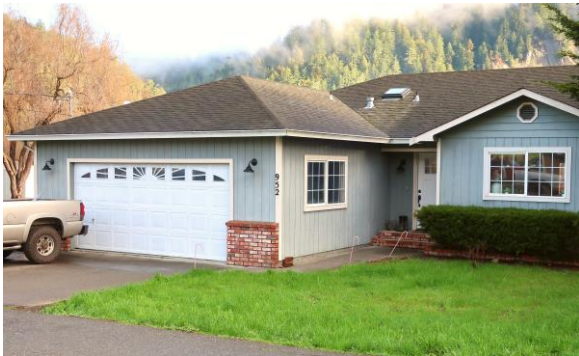
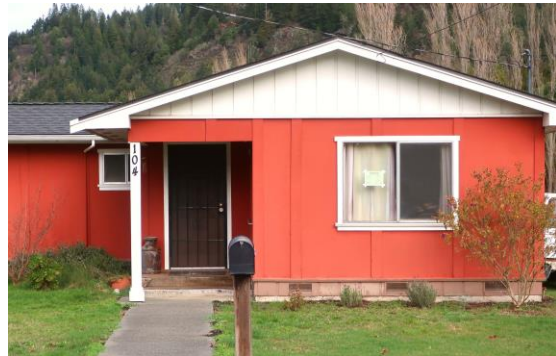
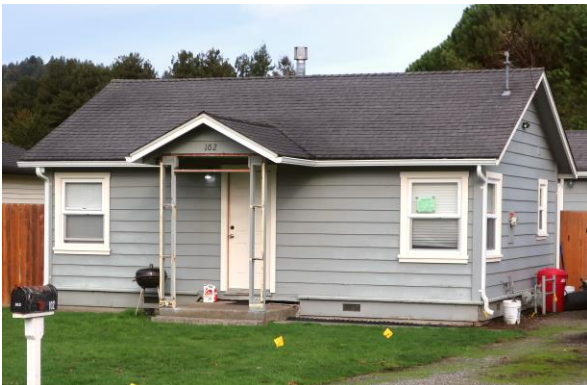
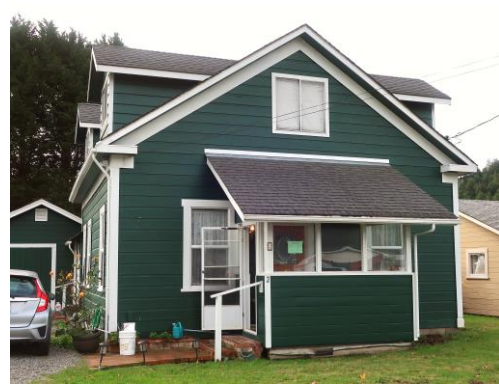
Many site-built homes of various ages had no apparent damage as illustrated in Figure 5.1. Virtually all newer homes like that shown in Figure 5.1a performed well by having no apparent structural damage.

Figure 5.1. Examples of homes located within 2000 feet of Painter Street Bridge (large recorded accelerations) having no apparent damage. Notice green-tags posted in windows. (a) Home built circa 2000. (b) Home built circa 1940. (c) Home built circa 1930. (d) Home built circa 1910, but resident says home was moved to current location many years ago. Many older homes have appearance of remodeling that might have included structural improvements.

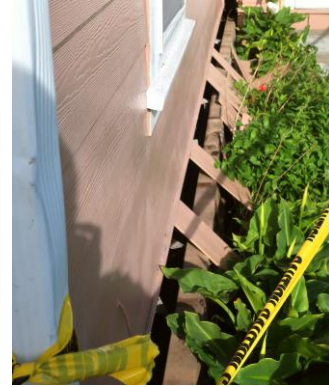
A common damage pattern observed was where the home behaved like a rigid box, but shifted at the foundation level (Figure 5.3). Such homes can often be repaired (Figure 5.4).

Figure 5.3. Examples of homes that shifted at floor level of raised-floor foundations. (a) Home that was offset west (to the left). (b) Close-up showing home shifted off foundation. (c) Before earthquake view of home having perimeter concrete masonry unit (CMU) wall foundation (undated Bing maps street view image). Home built circa 1948. (d) After earthquake view showing offset at foundation level.

Figure 5.4. Home undergoing repairs in May 2023. This was the home that shifted off its foundation shown in Figure 5.2a. The home was lifted up and placed back on a new foundation.

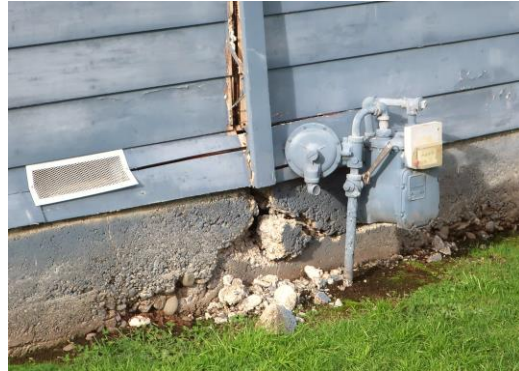
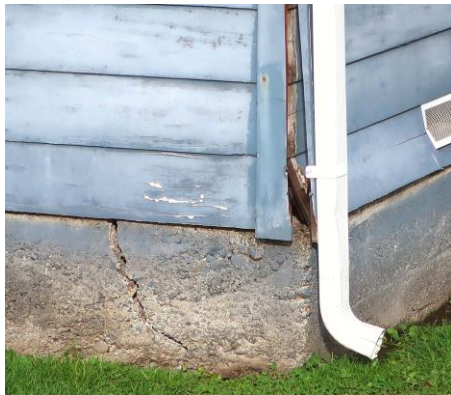
Figure 5.5 shows a home that had offset at the raised-floor foundation as well as cracking of perimeter concrete footing. This was one of the few cases observed having significant damage to the footing.

Figure 5.5. Example of home having offset at raised floor and cracking of perimeter concrete footing. (a) Exterior view of home. (b) Close-up view of fracture at cold joint apparently having inadequate bonding between layers of concrete. Home offset indicated by gap behind vertical molding. (c) Vertical crack in footing. Home offset indicated by splitting of molding at corner of home. (d) Vertical crack in footing.

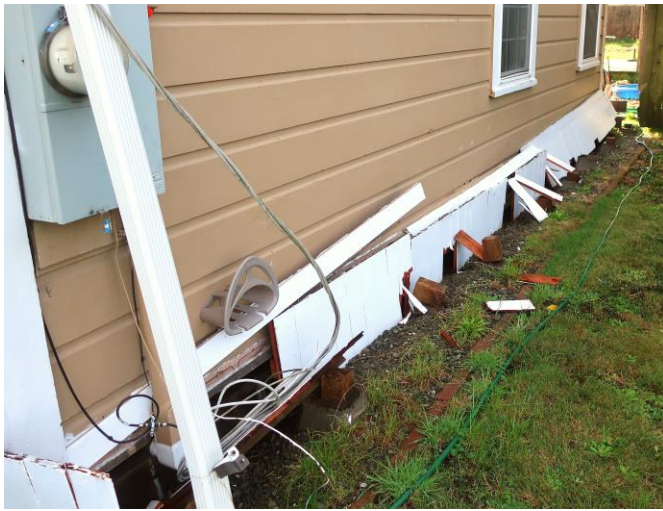
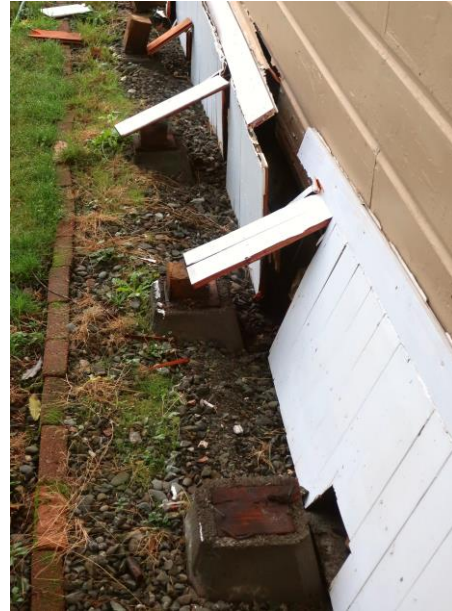
Figure 5.12 shows an older home built circa 1910 that suffered damage. Neighbors stated that home was relocated to current site many years ago. The raised floor foundation system consisted of precast concrete piers and short wood posts supporting the wood floor system (post-and-pier system). The home was completely thrown off its foundation. The home itself behaved like a rigid box and appeared to have no significant structural damage (Figure 5.12b). Figures 5.13, 5.14 and 5.15 show damage at the foundation level caused by the earthquakes.

Figure 5.14. Views along west side of home. (a) View B (Figure 5.13a). Home fell to the ground and post and piers broke through siding as home shifted east (to the left). (b) View C. Close-up showing post and piers that broke through siding as home shifted east (to the right).

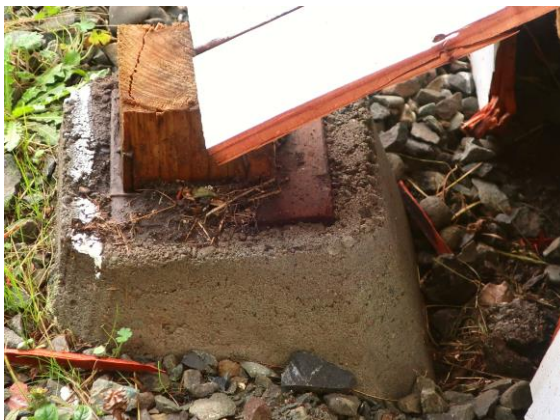
Figure 5.15. Detailed views of post-and-pier foundation system. (a) Close-up view of precast concrete pier with short 4x4 block on top. Siding sitting on top of post as home shifted to the right. (b) Close-up view of short 4x4 post lying on its side on top of pier. The assembly broke through siding as home shifted east (to the right). Post was toenailed to pier. Siding nailed to home but not connected to ground.

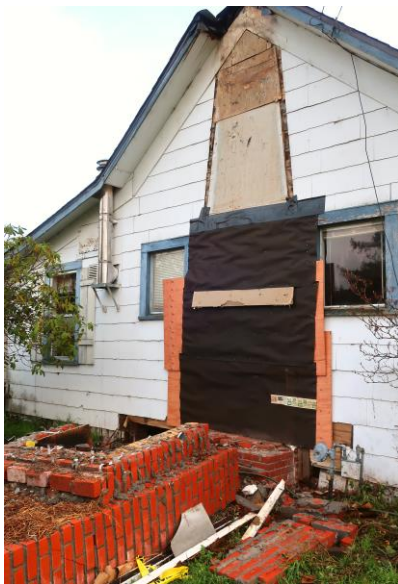
Figure 6.4. Additional photos of chimney collapse in Figure 6.3. (a) Cracking through bricks indicating good quality mortar. (b) Chimney broke off near base. (c) No signs of strapping to home. (d) Exposed rebar indicating pull-out. Four #4 bars present. Notice the good quality of mortar and use of modern deformed rebar. It is likely that the chimney was a replacement constructed some time after home was built circa 1935.

Figure 6.5. Home undergoing renovation in May 2023. This is the home that had its chimney tip over (Figure 6.3). The replacement chimney consists of a metal flue within a wooden enclosure. This is common chimney replacement practice.

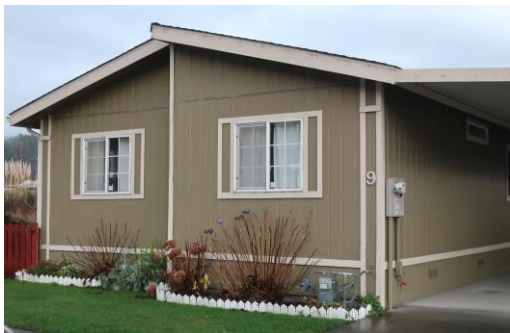
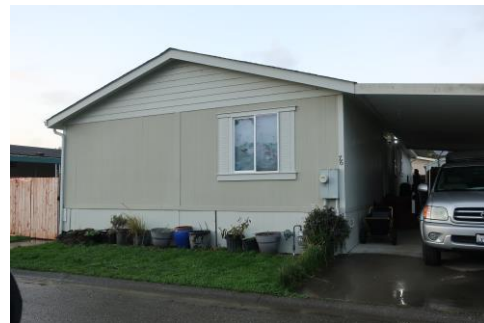
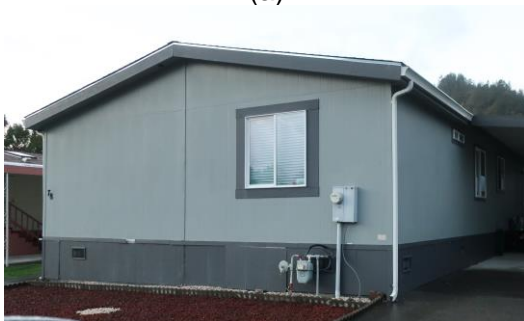
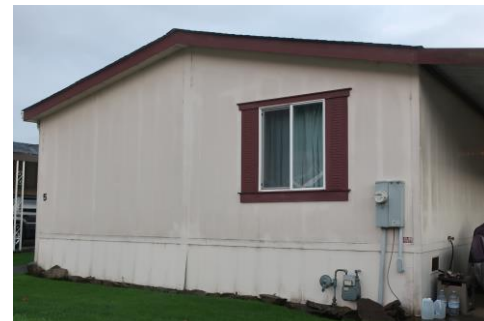
Virtually all the homes had no apparent damage as illustrated in Figure 7.1.

Figure 7.1. Examples of homes having no readily apparent damage. Damage usually indicated by significant offset or distress in skirting at base, and some homes might have very slight shifting from earthquake. Wood or composite material siding as opposed to metal sheathing typically indicates newer style home.

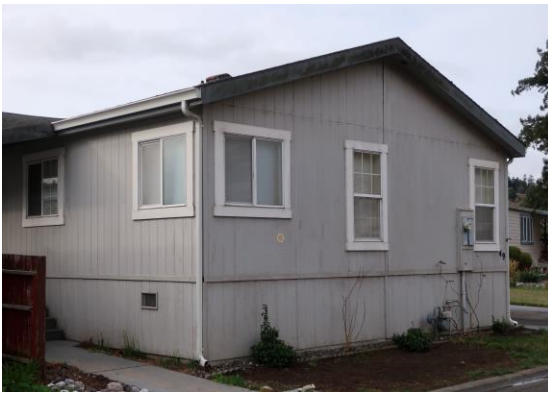
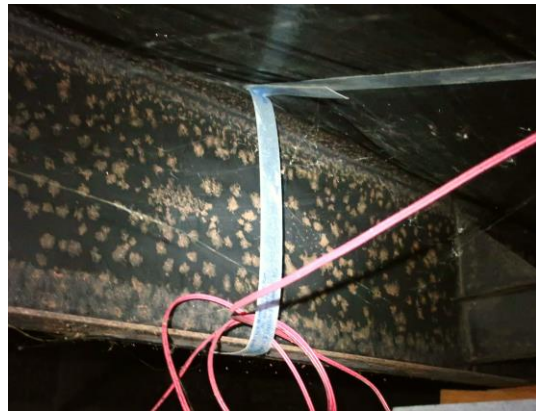
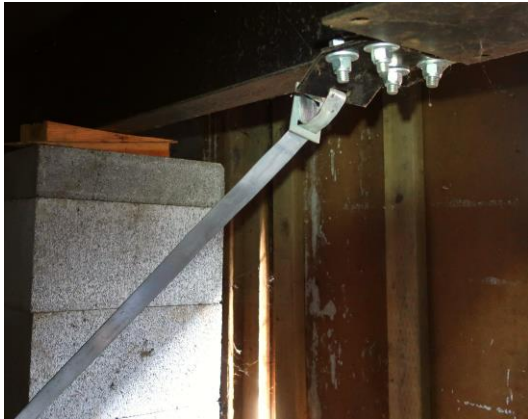
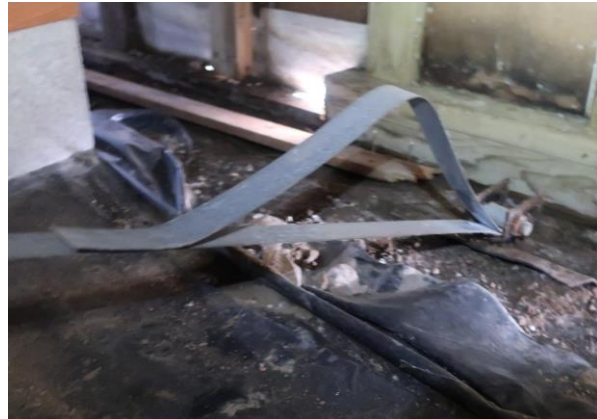
Figure 7.2. Conventional tie-down system. (a) Example of home showing no apparent signs of distress. (b) View underneath home showing standard practice of having tie-down strap wrapped around chassis girder (for tie-downs oriented in home transverse direction). (c) Tie-down connected to bracket at chassis girder bottom flange (for tie-downs oriented in home longitudinal direction). (d) Typical connection of tie-down to ground anchor.

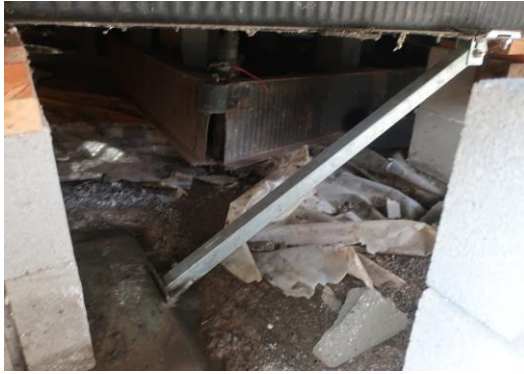
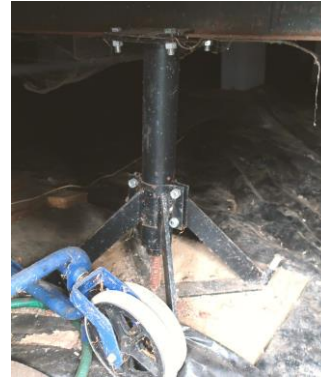
Figure 7.3. Some homes had proprietary bracing systems. All homes that allowed observations underneath had concrete masonry unit (CMU) piers. (a) Diagonal steel bracing system connecting chassis girder to concrete mat with CMU pier on top (at left). CMU pier provides dead load thereby clamping mat to ground. (b) Steel stanchion system connected to chassis girder and secured to ground by steel rods driven into soil.

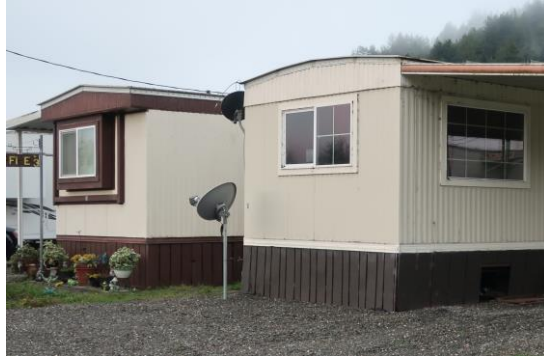
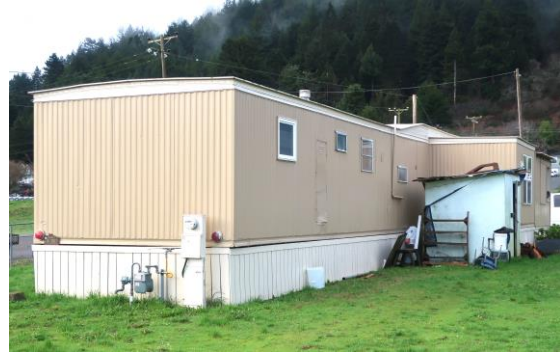
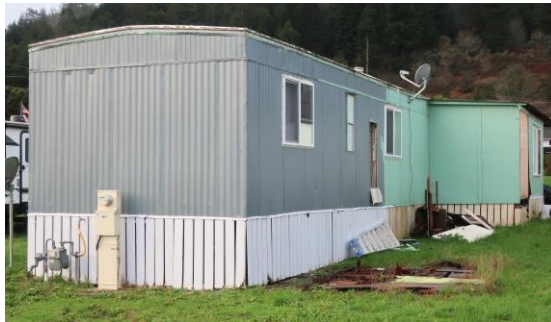
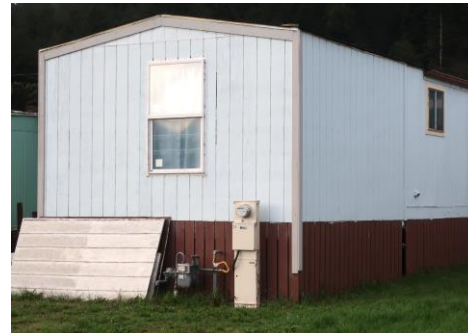
Typical homes are shown in Figure 7.6. MHP-B was established at the time when lateral force resisting systems such as tie-downs were not required. Homes that allowed access for underneath observations had no tie-downs. It is likely that few, if any, homes had tie-downs.

Figure 7.6. Examples of homes having no apparent damage. However, some might have had slight shifting from earthquake. Appearance of homes suggests that they are of similar age and likely installed at the time when tie-downs were not required by California (pre-1995 installations).

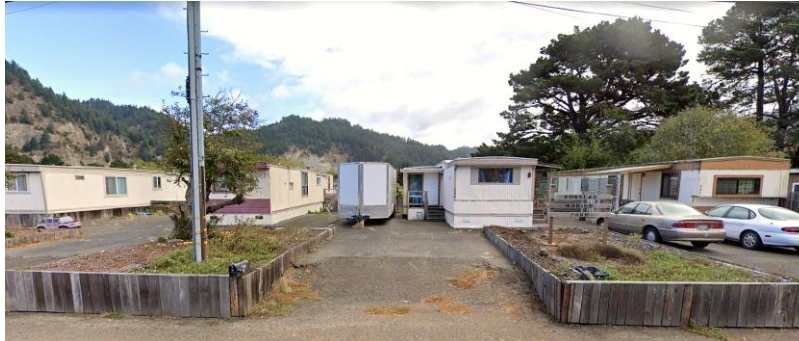
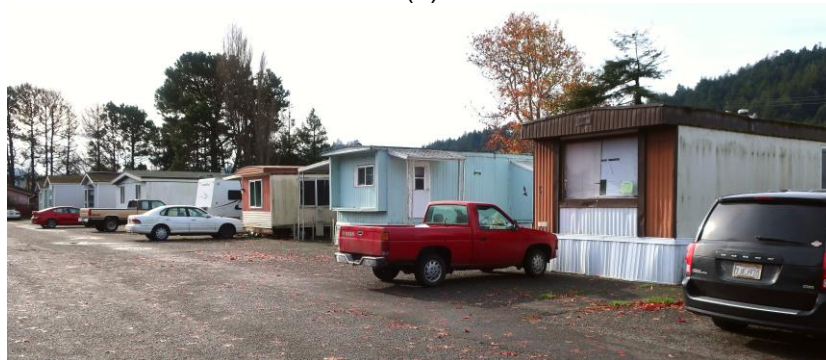
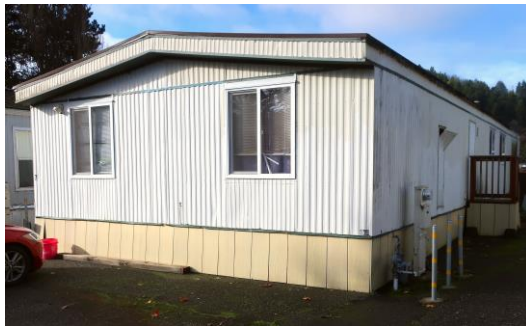
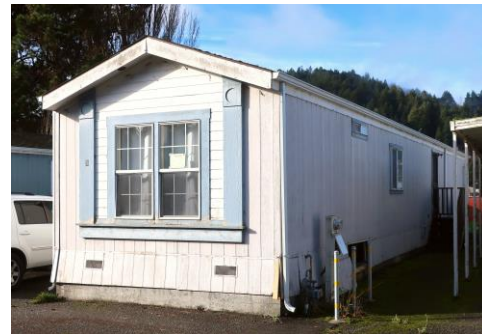
Typical homes are shown in Figure 7.10. MHP-C was established at the time when lateral force resisting systems such as tie-downs were not required. However, some homes had tie-downs. This was unexpected suggesting that some homes installed prior to 1995 used tie-downs, even though not strictly required. Alternatively, some homes might have been installed after 1994.

Figure 7.10. View of homes. (a) Before earthquake (undated Google maps street view image looking west). (b) View looking across street (to east). (c) and (d) Homes having no apparent damage. Appearance of many homes suggests that they are of similar age and were installed at the time when tie-downs were not required by California (pre-1995 installations). However, some homes had tie-downs.

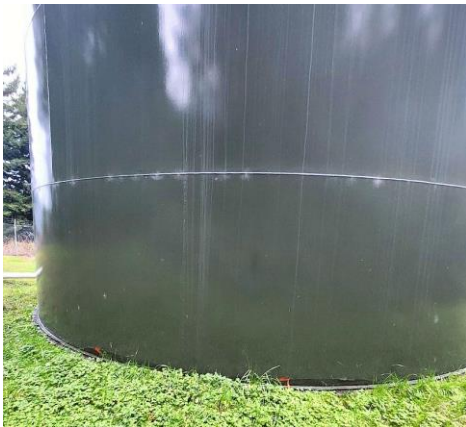
Water Tank Damage. One welded steel tank suffered damage and was shut down immediately following the earthquake (Table 9.2). Figure 9.3 shows photos of the Painter Street tank damage.

Name	Capacity	Construction	Comment
Painter Street	250k gal	Welded steel tank with no tie-downs.	Damaged in earthquake. Shell wall buckled. Broken pipe.
Dinsmore	200k gal	Bolted steel tank with tie-downs.	Some leakage at bolted joints that was remedied by bolt tightening.
Douglas #1	250k gal	Redwood tank.	Not in use at time of earthquake.
Douglas #2	500k gal	Bolted steel tank with tie-downs.	No damage.

Figure 9.3. Painter Street tank damage (photos courtesy of Randy Jensen). Tank constructed in 1956. (a) View of tank. Notice tank shell buckling at base. (b) Close-up view of tank wall buckling. (c) Water leaking from fracture of small diameter pipe (at center). (d) Tank shell buckling near outlet piping.

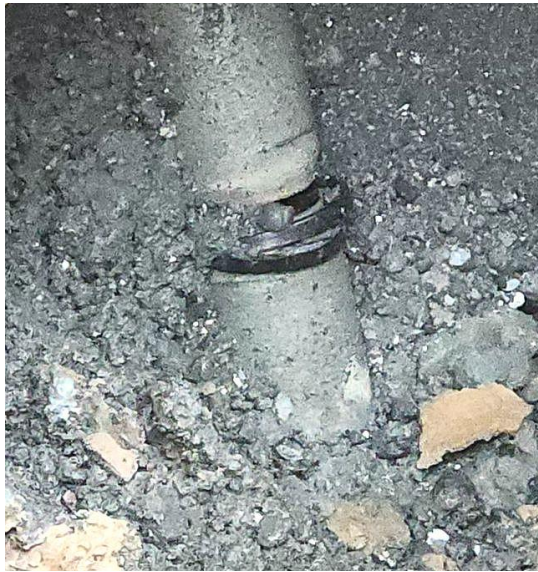
Pipe Damage at Highway Crossings. Table 9.3 contains the post-earthquake status of the crossings. Pipes at two crossings were severely damaged necessitating immediate valve closures to isolate the breaks. Damage was near

the thrust blocks where the pipe had angle changes. Figure 9.4 show photos of crossing #4 at Center Street.

Number	Pipe Type	Comment
#1	8 inch AC	No damage.
#2	10 inch HDPE	No damage.
#3	10 inch HDPE	No damage.
#4	6 inch AC	Pipe broke on both sides of highway near anchor blocks where pipe dipped down under roadway.
#5	6 inch AC	Pipe broke at west side of highway near anchor block where pipe dipped down under roadway.
#6	6 inch AC	No damage.
#7	10 inch HDPE	No damage. Transmission main from WTP to Douglas reservoirs
#7	8 inch steel	No damage. Raw water main from river infiltration galleries to WTP.

See Figure 9.1 for location of crossings. Highway 101 forms an underpass at Painter and Davis Streets where the highway lies below street elevations. Crossings #4 and #5 require pipes to dip down significantly to be below highway pavement.

Figure 9.4. Photos of pipe at highway crossing #4 (courtesy of Randy Jensen). (a) Separation of AC pipe at inclined run as it dips down under highway. (b) Installation of replacement PVC pipe. Notice the deep burial depth.
